**Background:** On November 2, 2020, Axon released an updated firmware for the TASER 7 Dock Charger, Firmware Version 1.0.17. This Bulletin can be viewed as an addendum to Training Bulletin 22.0-04 (which was released to notify the field of the firmware update) and serves to provide further background about this release and TASER 7 Dock Charger FW.

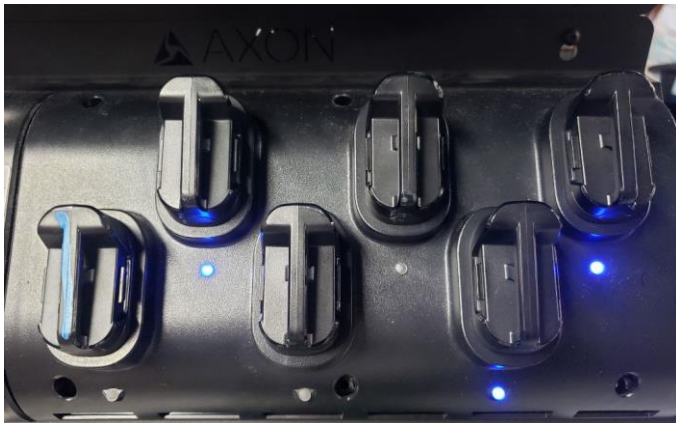
- **LED Indicator Change:** A blinking blue LED is shown on the TASER 7 Dock or Dataport to show users when a Log Sync Error is occurring. The LED will blink blue and yellow if the battery is charging, and will blink blue and green if the battery is fully charged.
  - The previous indicator for this error was a blinking red LED. This change was made so users can easily discern if a battery error is something that can be resolved immediately.
  - **To fix the Log Sync Error (blinking blue LED), follow these steps:**
    - Remove the battery pack from the dock.
    - Insert the battery into a TASER 7 CEW.
    - Wait for the hourglass to disappear from the CID (ensure that the CID is blank).
    - Remove the battery from the CEW.
    - Re-dock the battery pack.

Image showing a TASER 7 Six-Bay Dock where LED indicator is blinking blue to show that a Log Sync Error occurred on the battery pack.

- Once the battery pack is re-docked, it should show a blinking yellow LED (while the CEW log uploads) and then transition to a solid yellow LED.
- This change is shown in our newest TASER 7 Dock quick start guide which can be found on [help.axon.com](https://help.axon.com)
